# MAINTENANCE AT INCO GENERATING PLANT NO

# LONGER FRAZZLED BY DOWNTIME CONCERNS

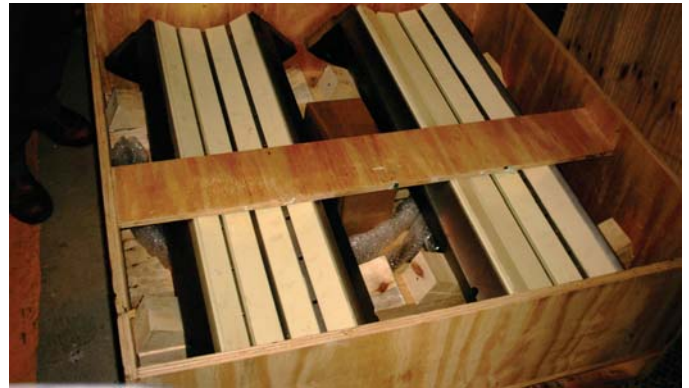
Split SXL Stave Main Guide Bearing

To reduce downtime in the future, Thornton and the engineers at Thordon Bearings recommended a stave configuration. This helped reduce the time it would take to remove, service and reinstall the bearings from the current standard of three to four months to just a few days!

stopped five times, each time running dry. The fear was that the bearing would be burnt and require immediate changeout, something that would be expected from a phenolic material. It wasn't. In fact, after inspection, Thordon SXL was only mildly scuffed.

"And the good news is," says Thornton, "Inco's maintenance staff was able to clean the exfoliated material from the water grooves and

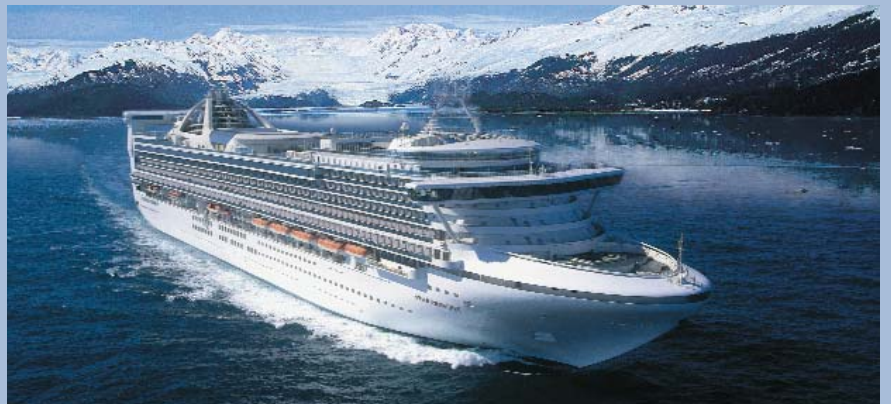
Star Princess Equipped With COMPAC Water Lubricated Propeller Shaft Bearings Since 2002

pollution or subsequent environmental violations that could result from stern tube oil leakage, however small. There are currently over 380 Commercial and Naval vessels that are equipped with Thordon COMPAC water lubricated propeller shaft bearings plus many more on order. **Nw**
