**Industry:** Sewage and Water Treatment  
**End User:** Watercare Mangere, New Zealand  
**Application:** Peak Cap Bearing in Primary Sedimentation Tanks  
**Thordon Grade:** SXL  
**Date of Original Installation:** 2010

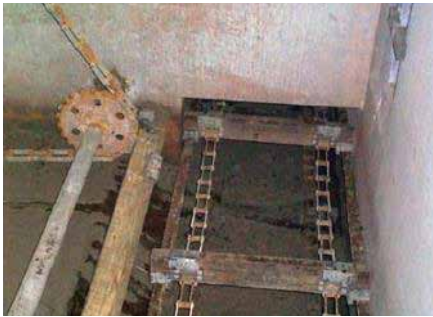
*Typical PST (Primary Sedimentation Tank) Setup*

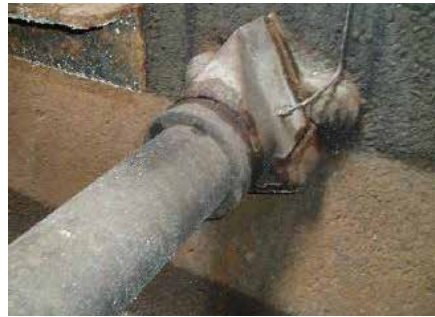
*Peak Cap bearing, shaft and grease line*

One of the issues with the greased white metal (Babbitt) bearings is the grease lines as they can be subject to damage from sticks, rags or trash moving through the tank. If the grease doesn't get to the bearings for any reason, then the bearings will gall, pick up or seize. Dewatering a tank in order to replace the bearings costs a lot of time and money.
