Industry: Earth Moving
End User: Bob Hick Earthmoving – New Zealand
Application: Cat 615 Motor Scraper Elevator
Thordon Grade: ThorPlas-Blue
Date of Original Installation: July 2016

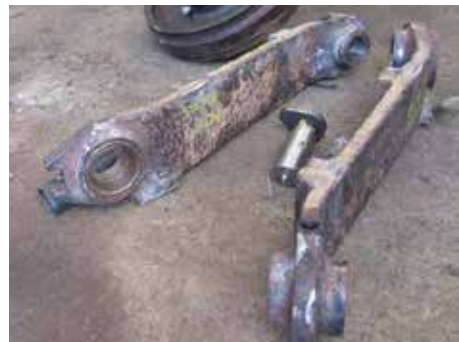
Engineers at Bob Hick Earthmoving - New Zealand were having trouble with the existing steel bearings in the support brackets on the elevator lift lasting.

Elevator Support and Existing Steel Bearings

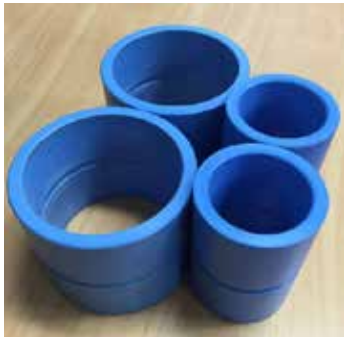
*ThorPlas-Blue
Replacement Bearings*

The Thordon Engineers at Pacific Driveline suggested using ThorPlas-Blue as the bearing material. Since the pin was hardened steel, it was prone to corrosion and would still need to be greased..

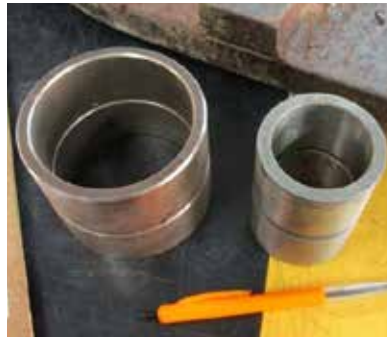
Old Steel Bearings

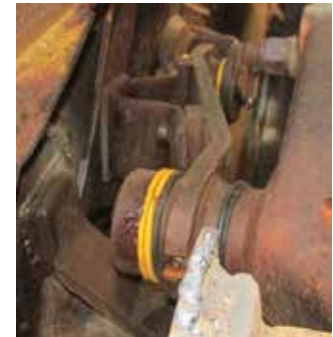
*ThorPlas
installed with O-rings*

The ThorPlas-Blue bearings were installed into the elevator support arms and greased to prevent corrosion of the pin. Grease exposed to dirt becomes a grinding paste and accelerates wear of the pin and bearing. To prevent this happening yellow and black O-rings have been installed at the joints (see photo above) to keep the grease in, under a little pressure, and keep the dirt out. The expectation is for many years of service.
