CATERPILLAR 615-C MOTOR SCRAPER BEARINGS

Industry:	Earth Moving
End User:	Bob Hick Earthmoving – New Zealand
Application:	Cat 615 Motor Scraper elevator
Thordon Grade:	ThorPlas Blue
Date of Original Installation:	July 2016

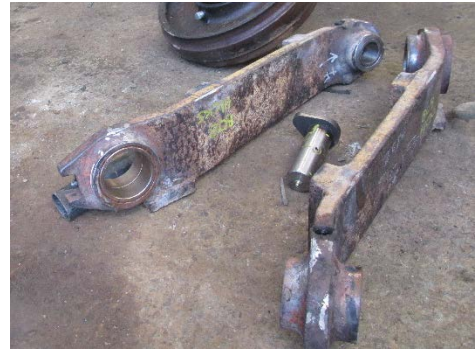
Engineers at Bob Hick Earthmoving New Zealand were having trouble with the existing steel bearings in the support brackets on the elevator lift lasting.

Elevator Support and existing Steel Bearings

The Thordon Engineers at Pacific Driveline suggested using ThorPlas Blue as the bearing material. Because the pin was hardened steel and therefore prone to corrosion grease would still be needed.

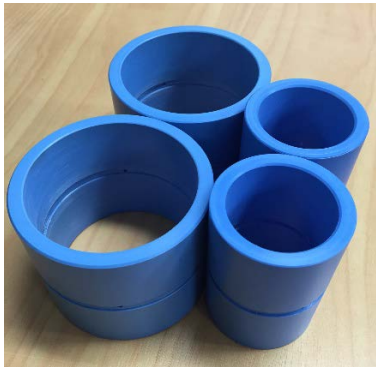
ThorPlas Blue replacement bearings

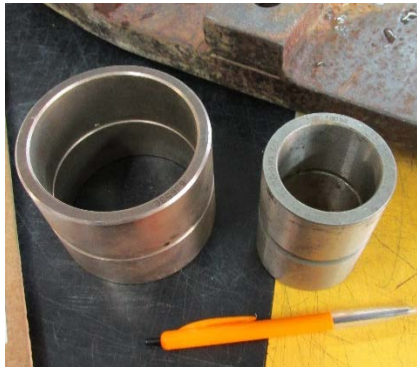
Old Steel Bearings

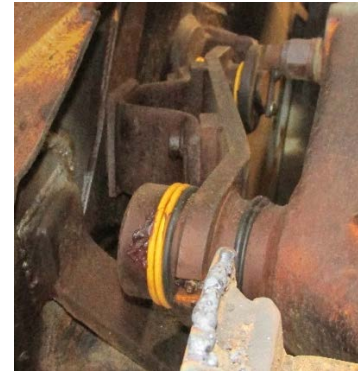
ThorPlas installed with O rings

The ThorPlas bearings were installed into the elevator support arms and greased to prevent corrosion of the pin. Grease exposed to dirt becomes a grinding paste and accelerates wear of the pin and bearing. To prevent this happening yellow and black O rings have been installed at the joints (see photo above) to keep the grease in, under a little pressure, and the dirt out. The expectation is for many years of service.
