**Industry:** Sewage & Wastewater

**End User:** Large Wastewater Treatment Facility, Ontario, Canada

**Application:** RAS (Return Activated Sludge) – Horizontal Pump Wear Ring

**Thordon Grade:** SXL

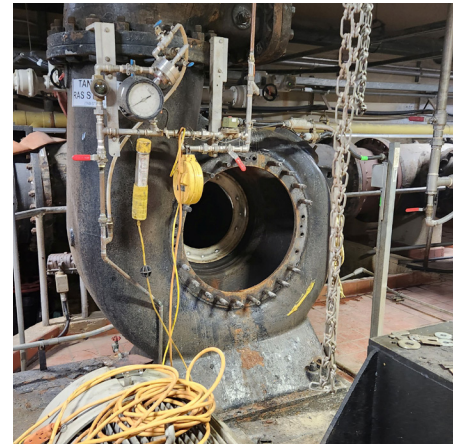
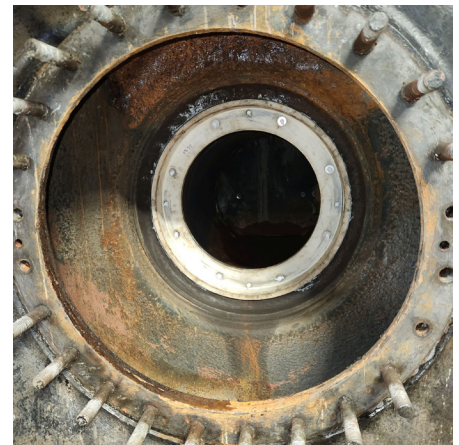
In early 2023, Millstream designed and supplied a direct fit replacement wear ring machined from Thordon SXL. The customer reported improved pump efficiency from the tighter running clearance that was achieved, as well as greatly improved durability. The first wear rings have been in service for just over 1 year, and monitoring of performance on multiple pumps is on-going.
