**Application:** Landing Craft Utility (LCU) Ramp Door Hinge Bushing System

**Thordon Grade:** ThorPlas-Blue

**Date of Initial Installation:** September 2017

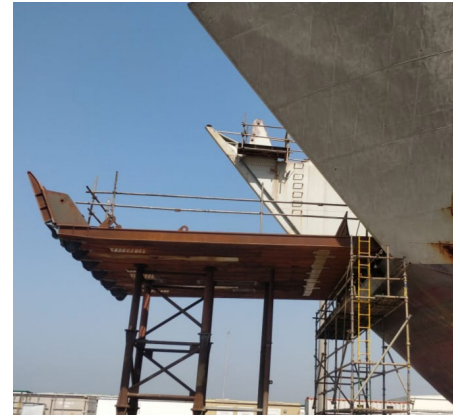
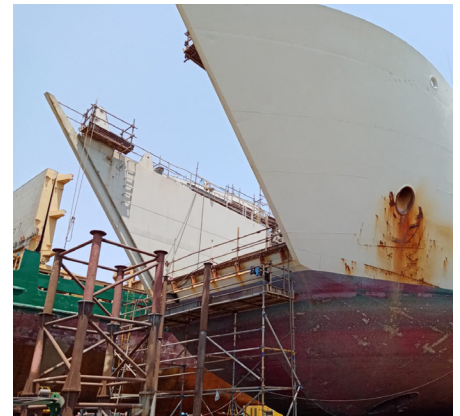
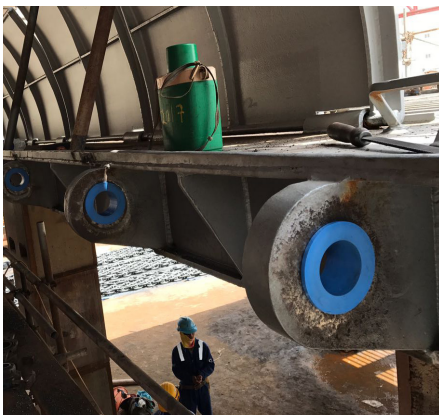
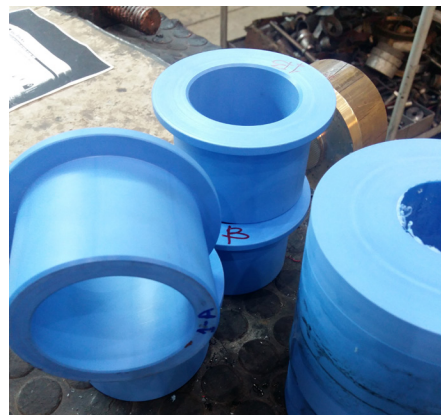
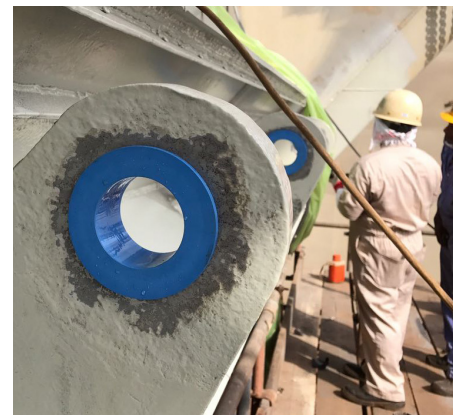
The hinge bushing is located outside the landing ramp, facing the sea elements. When the vessel is sailing, it is impossible to grease the bushing at regular intervals when the ramp door is closed.

Due to the lack of lubrication, the grease combines with dirt, moisture and corrosion particles and became sludge, leading to the following problems:

- Seizing of the pin to the bronze bushes
- Increased wear & damage of the bronze bushes
- The ramp doors did not open and close smoothly.
- Unnecessary maintenance delays to grease the bushings
- Very noisy during opening and closing

In September 2017, and again in May 2019, ThorPlas-Blue was installed to completely eliminate the issues of improper lubrication, seizing, increased wear and delays.
