**Industry:** Marine - Workboat

**End User:** Triple-Screw Workboat Operator on the Mississippi River, USA

**Application:** Tiller & Jockey Bar Steering Linkage System

**Thordon Grade:** ThorPlas-Blue

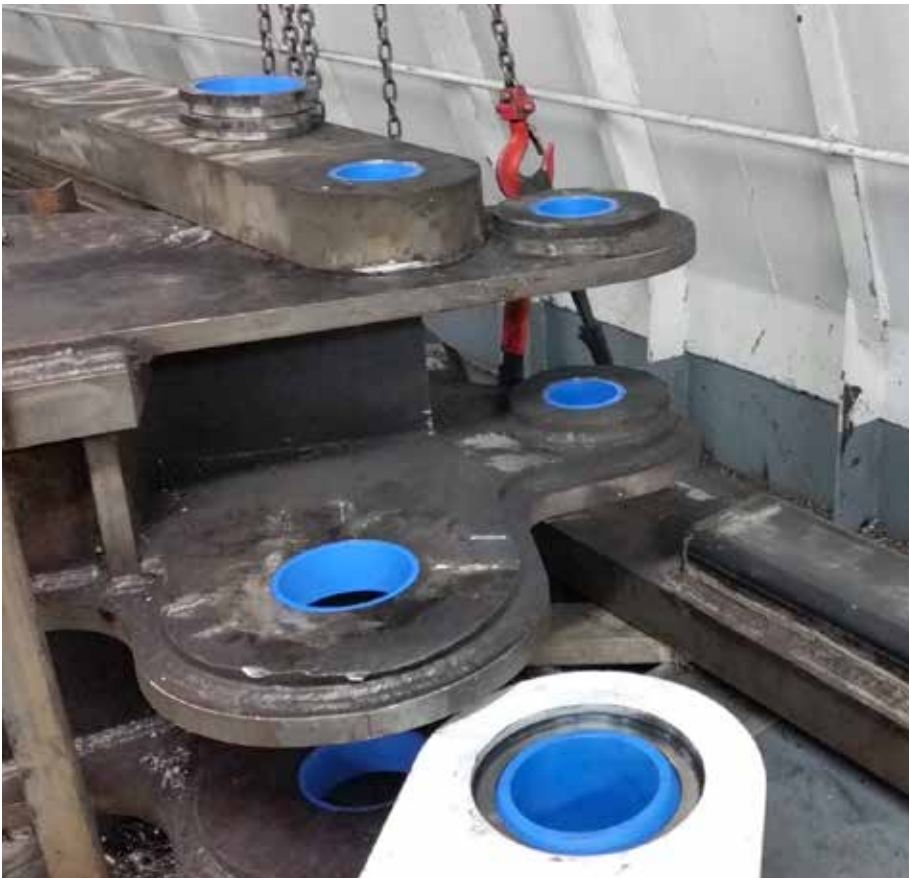
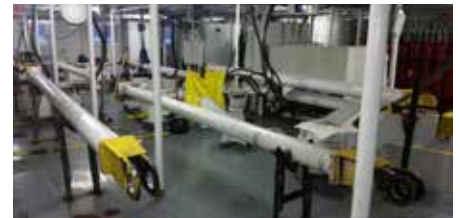
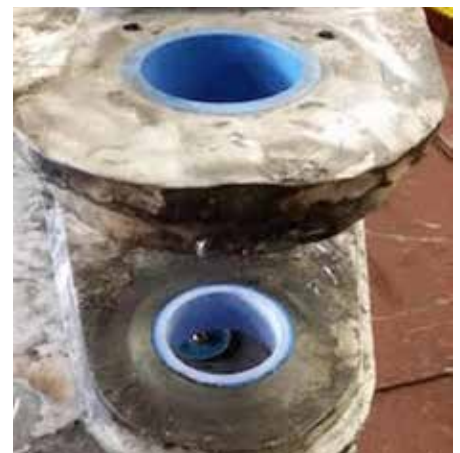
The ThorPlas-Blue installation took place in 2016. Prior to the retrofit project, Mactech measured and recorded all as-found bushing data before creating a mock-up steering linkage, as they do for all retrofit projects. The steering system for the retrofit vessel consisted of three steering quadrants, six flanking quadrants, two dummy flanking quadrants, and associated jockey bars. New bushings were machined to size before fitting to quadrants and jockey bars. New wear plates were then manufactured for each pin joint and the steering system was reassembled with new pin retainers.

The flanking quadrants were very close to the floor and allowed for limited space for machining them as the welding, electrical, and machining work happened simultaneously in a small area. Every bore in the system had to be machined to a nominal size. Mactech's equipment was very flexible and worked well in difficult spaces with innovative fixturing. The company's unique processes of controlling bore sizing were essential for the duration of the project. Good planning, staging, and communication to accommodate other crafts working in the same area added to the success of the project.

At various times the vessel's steering gear was spot checked by pulling the tiller pins and measuring the internal diameter of the bushings. Based on measurements taken by Mactech and the customer, the bearings have experienced "no measurable wear."
