Converting An Icebreaker From An Oil Lubricated Stern Tube Bearing System To A Seawater Lubricated Stern Tube Bearing Considering Environmental And Operating Costs

Mr. Ken J. Ogle, C.Eng, MIMarEST.
Director of Engineering, Thordon Bearings Inc.
Burlington, Ontario, CANADA
keno@thordonbearings.com

Mr. Craig D. Carter, MBA
Director of Marketing and Customer Service, Thordon Bearings Inc.
Burlington, Ontario, CANADA
craigc@thordonbearings.com

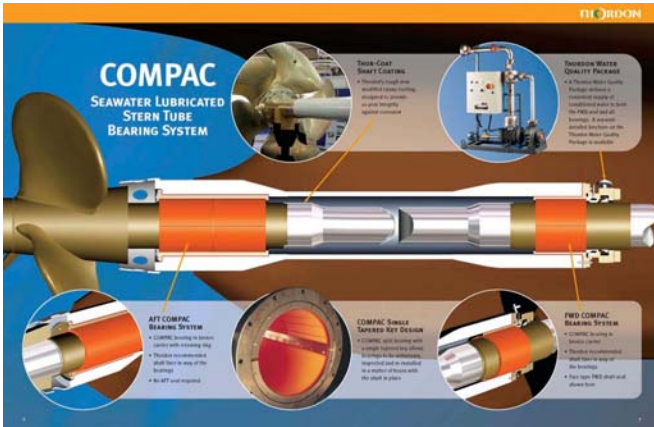
The simplest way to completely eliminate oil leakage from the stern tube is to use seawater as the lubrication and cooling medium with Thordon non-metallic bearings in place of the white metal bearings. The seawater is taken from the sea, pumped through the bearings and returns to the sea. The seawater enters the forward section of the stern tube immediately aft of the seal. The seawater passes through the forward and then aft bearing prior to re-entering the sea as shown in Figure 1.

Figure 1. Thordon COMPAC seawater lubricated stern tube bearing system

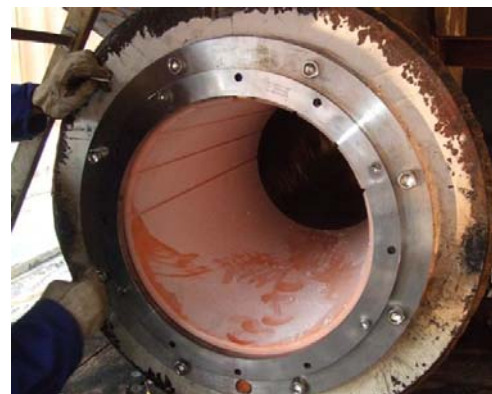
Figure 2. Retaining ring fitted to COMPAC bearing carrier

Thordon COMPAC bearings had been pre-machined to the design dimensions ready for installation. The bearings were slotted to mate with the anti-rotation keys already fitted in the carriers. The bearing elements were freeze-fitted into the carriers - liquid nitrogen was used as coolant and only 10-15 minutes immersion time was needed to shrink the bearings enough that they were inserted into the carriers by hand. The retaining rings were then fitted and secured to complete the bearing installation.

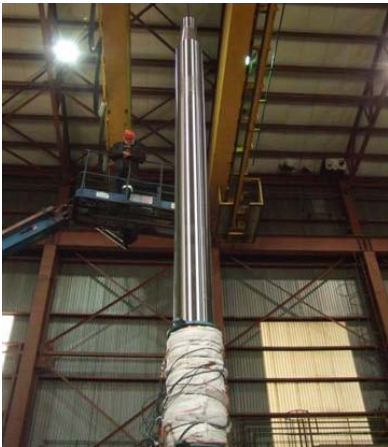
Figure 3. Steel shaft and liner, vertical.

The shafts were cleaned and finished with a 400-grit belt in preparation for the liners. The liner bores were machined to give 0.5mm (0.020”) interference to the shafts. The liners were heated to 300°C (570°F) using electric heating elements and then slid into position on the shafts and allowed to cool. The aft liner extended to just in front of the propeller flange radius (the radius was left uncovered as is a Class survey item) so it can be finally sealed to the flange shroud with an O-ring. The forward liner extended through the seal position and into the shaft alley. In this instance, the liners were fitted with the shafts vertical as shown in Figure 3, however it is also common to slide heated liners into position along shafts horizontally as in Figure 4.

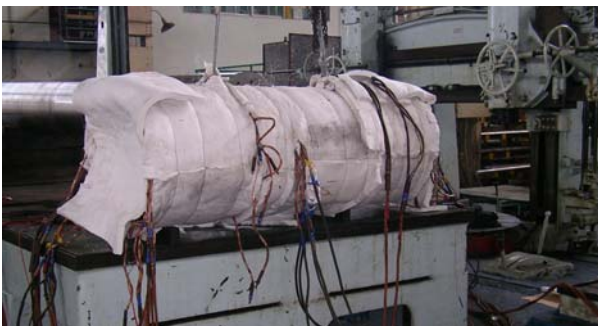
Figure 4. Liner heated for installation, horizontal.

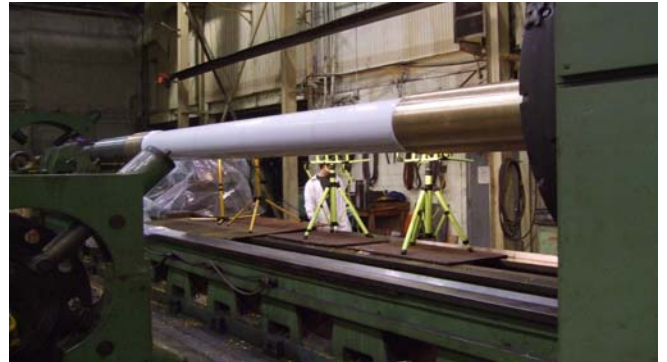
Figure 5. Thor-Coat shaft coating applied to shafts.

The shafts were sand blasted and thoroughly cleaned with MEK to remove any grease or other residue. The Thor-Coat was applied as the shafts were slowly rotated in a lathe. The coating was applied to a minimum of 2mm (0.080”) thickness, with checks made periodically during the application using a wet coating thickness gauge.

Again, this was in Canada during the Autumn season, so four twin heating lamps at 2x500W each were used to warm the shafts towards 30°C (86°F) for seven hours to ensure efficient curing of the coating.

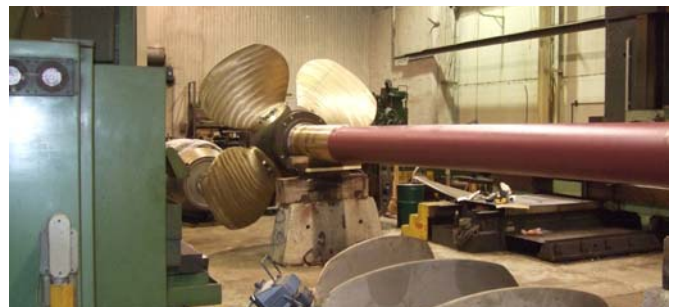
Figure 6. Shaft coated with a tin-free anti-fouling paint.

Next day, the Thor-Coat was visually inspected and the coating continuity checked with a “Holiday” detector set to 11.1kV. The dry film thickness was also verified as not less than 2mm (0.080”) using a Positector 6000 coating thickness gauge. To discourage marine growth on the Thor-Coat surface, a tin free anti-fouling paint from Ameron Marine Coatings was then applied by brush and roller as shown in Figure 6.

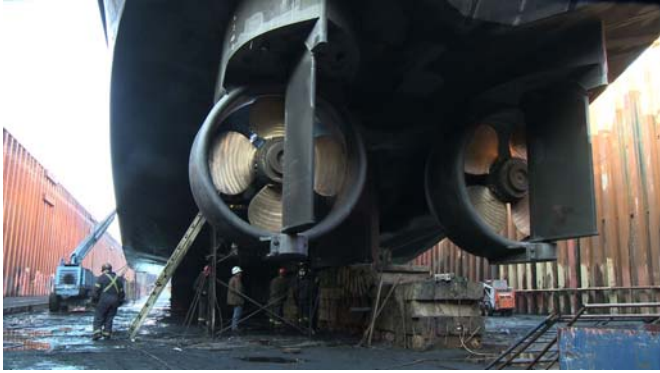
Figure 7. Propeller shafts installed

The shafts were installed in the stern tubes. When handling it is important to protect the Thor-Coat shaft coating from mechanical damage - rubber sheeting was used under the slings. Liquid hand or dish soap was used as a temporary lubricant as the bronze liners were slid through the COMPAC bearings.

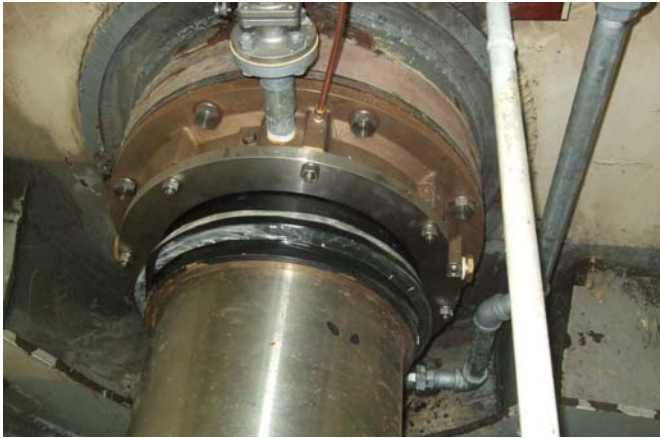
Figure 8. Installation of forward axial seal

New seals were procured from Sternkeeper of Japan. The new seal is of the axial type and uses a rotating rubber sealing lip acting axially against a stationary Chrome-steel face. The unit also includes an 'emergency seal', pneumatically energized to seal against a stopped shaft and enable maintenance of the operational seal without having to drydock the vessel.

The seals were installed to the maker's specifications and tested successfully to 3bar water pressure.

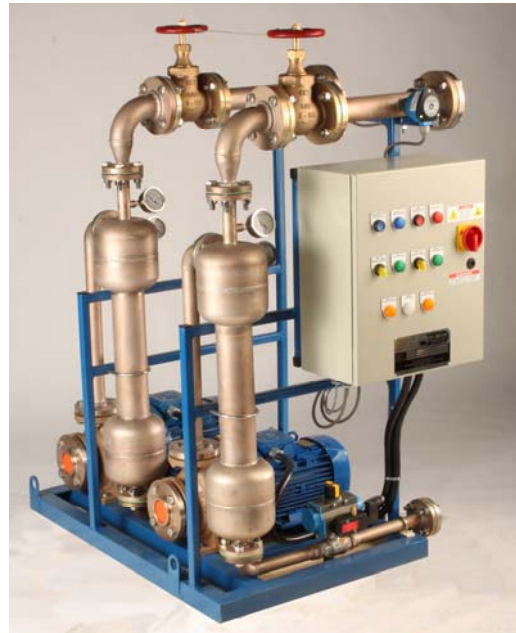
Figure 9. Thordon Bearings Water Quality Package

Thordon Bearings offers Water Quality Packages which include pumps, cyclonic separators and automation as a "plug-n-play" unit as shown in Figure 9. The separators are rated to remove particles greater than 80µm with specific density greater than 1.2. The collected debris is automatically purged overboard on a timed basis. For this vessel, 2 units were supplied, one per shaftline.

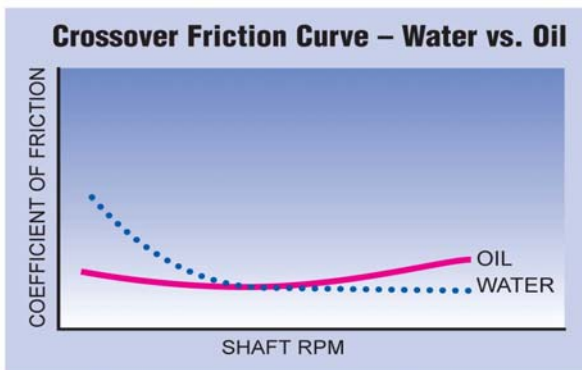
Figure 10. Friction curves, water vs. oil

Power losses with hydrodynamic operation are attributable to shearing of the fluid film. Since water is less viscous than oil, operation with water should theoretically result in less power loss within the bearing as shown in Figure 10 - with potential fuel savings.
