Reducing Maintenance with Water Lubricated Turbine Guide Bearings - Design Principles & Case Studies

G. Auger, P.Eng.
Thordon Bearings Inc.
3225 Mainway
Burlington, ON
Canada

Abstract

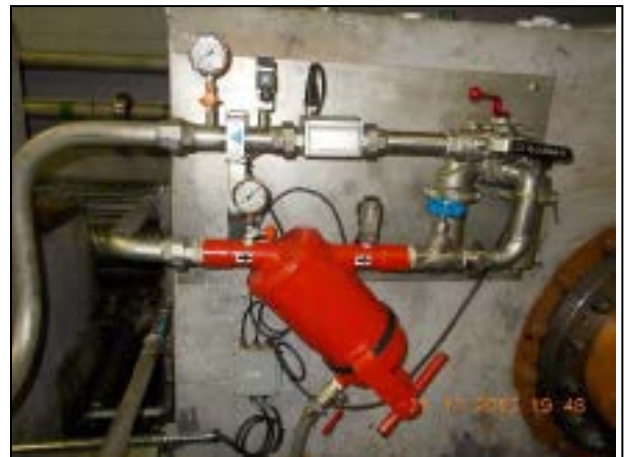
Water for bearing cooling & lubrication was supplied above the bearing and below the shaft seal at a flow rate of 150 – 180 L/min, with a minimum pressure of 2 bar in order to ensure positive water flow direction through the bearing at all times. In this installation, water was taken from the high pressure supply available from the penstock, which was then filtered to remove large abrasive particles that could shorten the bearing life. The water system utilized a self-cleaning cyclone type pre-filter, followed by a double inline filter of 60 micron. A pressure regulating valve was incorporated to reduce and control water supply pressure, and a flow control valve was included to allow the correct flow rate to be achieved. An ultrasonic flow meter, as well as pressure gauges and switches were provided to connect with the turbine control and alarm system. The control system was configured to confirm correct water flow & pressure as a pre-condition to allow unit start-up.

Figure 6 - Water Filtration System

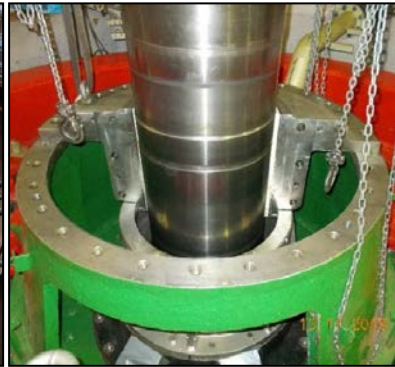
Figure 8 - Bearing Installation

After completing the fabrication of all components, the bearing and shaft seal was installed successfully at the site in November of 2015.

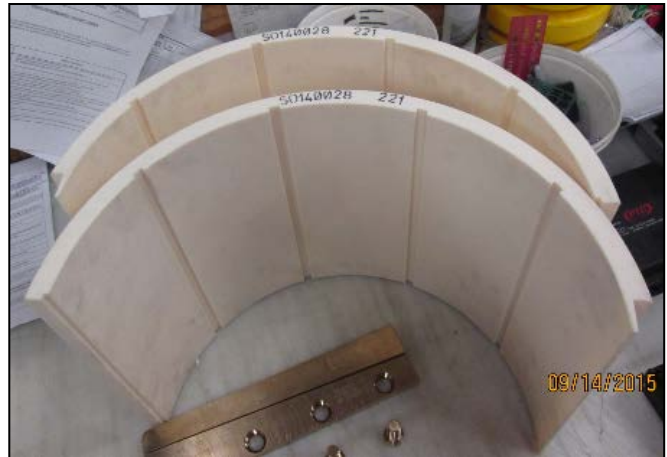
Rather than securing the elastomer bearing material by bonding, in this project the bearing was installed using a tapered keyset design to create an interference fit between the bearing and the steel housing. This configuration allows for easy servicing or inspection of the water lubricated bearing inserts, reducing downtime associated with any bearing problems that may be encountered in the future.

Figure 12 - Thordon SXL with Tapered Keyset

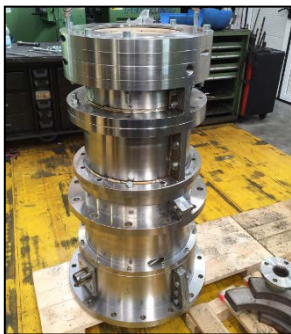
Figure 13 - Complete Assembly

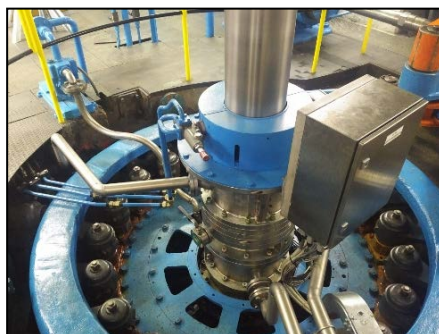
Figure 14 - Installed Bearing & Seal

Initial trials went well with a planned stop for inspection several weeks after the initial start-up. The unit was stopped to inspect the bearing and shaft seal. There was some observation that the initial water leakage from the shaft seal was quite high, but after investigation it was discovered that there was a problem with the orientation of the seal segments and after correcting this the leakage stabilized at an acceptable rate of <10 L/min.

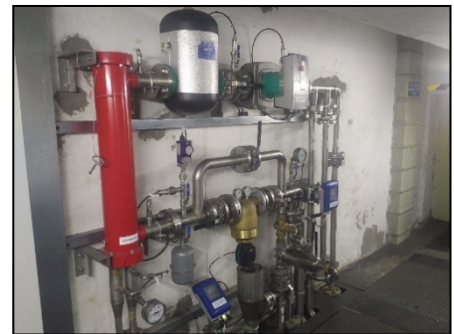
Figure 15 - Water Filtration System

The filtered water system configuration was also slightly different, with water entering the assembly below the bearing and moving upwards through the bearing to the shaft seal. Some minor leakage was expected through the runner gap and also through the shaft seal, but this configuration created a semi-closed loop system that reduced the total consumption of clean water while still maintaining the minimum required flow rate required through the bearing space to cool and lubricate the bearing.
