## CATERPILLAR 615-C MOTOR SCRAPER BEARINGS

<b>Industry:</b>	Earth Moving
<b>End User:</b>	<b>Bob Hick Earthmoving – New Zealand</b>
<b>Application:</b>	Cat 615 Motor Scraper elevator
<b>Thordon Grade:</b>	ThorPlas Blue
<b>Date of Original Installation:</b>	July 2016

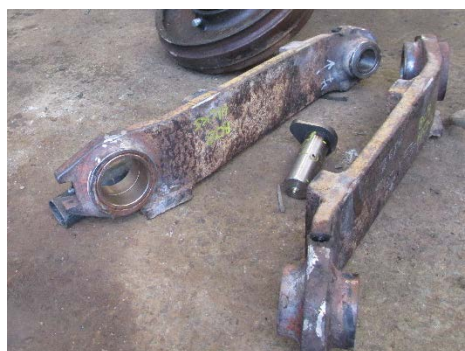
Engineers at Bob Hick Earthmoving New Zealand were having trouble with the existing steel bearings in the support brackets on the elevator lift lasting.

Elevator Support and existing Steel Bearings

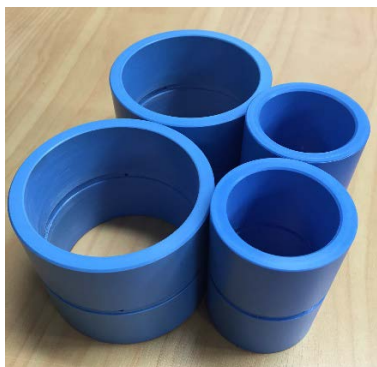
ThorPlas Blue replacement bearings

The Thordon Engineers at Pacific Driveline suggested using ThorPlas Blue as the bearing material. Because the pin was hardened steel and therefore prone to corrosion grease would still be needed.

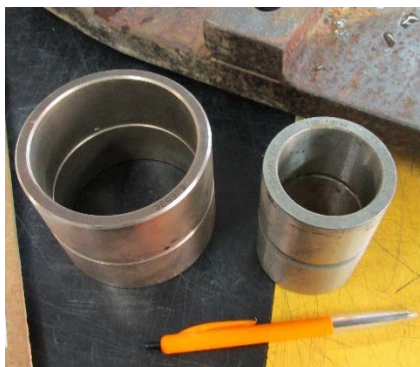
Old Steel Bearings

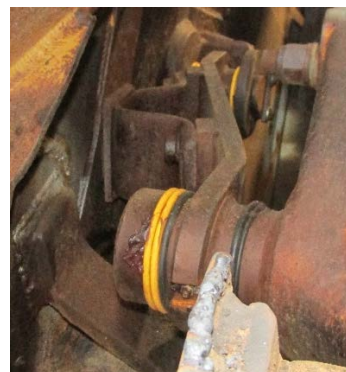
ThorPlas installed with O rings

The ThorPlas bearings were installed into the elevator support arms and greased to prevent corrosion of the pin. Grease exposed to dirt becomes a grinding paste and accelerates wear of the pin and bearing. To prevent this happening yellow and black O rings have been installed at the joints (see photo above) to keep the grease in, under a little pressure, and the dirt out. The expectation is for many years of service.
