Thordon Rides the Trolley Bus

Typical Trolley Bus owned by Mass Urban Transit Company (MUTC) in Pardubice, Czech Republic

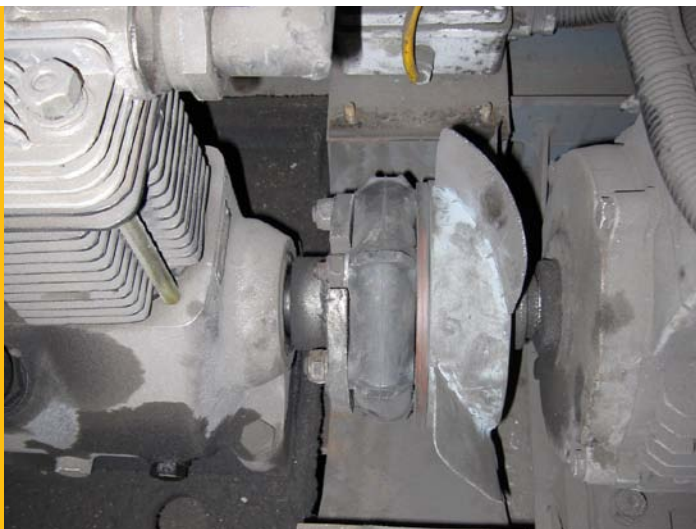
MUTC public trolley bus hardy clutch system

Mass Urban Transit Company (MUTC) in the city of Pardubice was spending far too much time and money on replacing parts of their Hardy Clutches, which consist of a carrier plate and three damper elements.

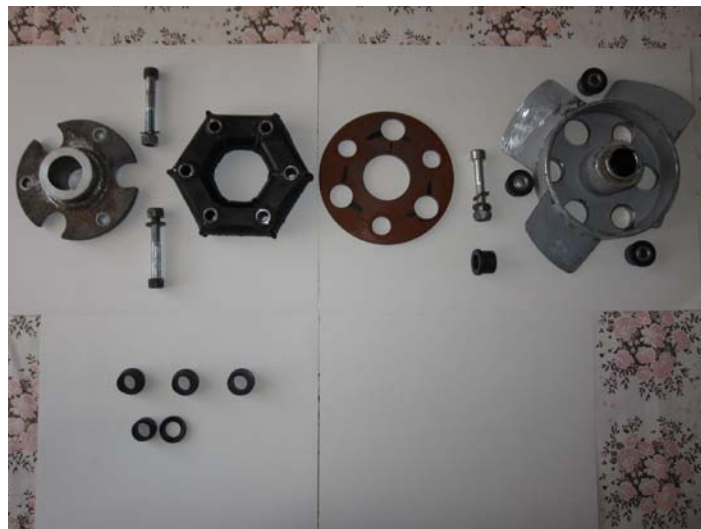
MUTC disassembled trolley bus hardy clutch system

"When they dismantled the Hardy clutch a week later," says Piroutek, "they found almost all Thordon pieces intact. Only ThorPlas-Blue had very small dimensional changes of less than 0.5 mm."

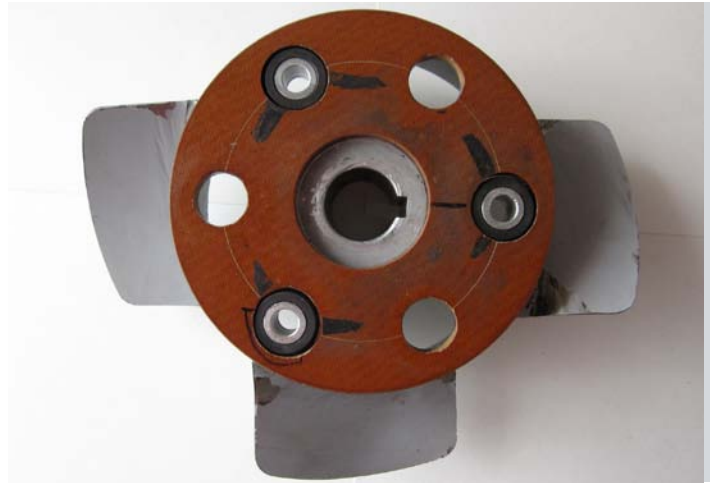
Replacement of clutch Pentinax part with Thordon XL

Thordon's Business Development Manager, Greg Auger recommended replacing the clutch's Pertinax part with Thordon's shock-resistant XL, and replacing the Tecamid part with the durable ThorPlas-Blue. Because Thordon materials had not been used in buses before, the only way to know if they would withstand the shock loads was to test them. The bus company agreed to try the parts for two months.

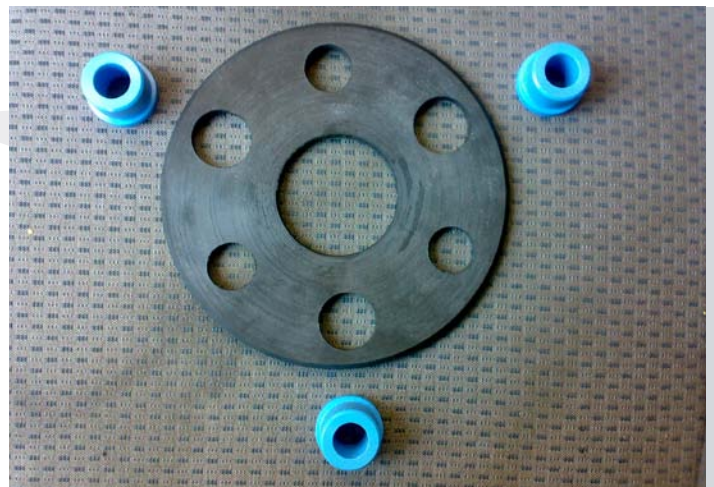
Replacement of clutch Tecamid parts with ThorPlas-Blue

the technical manager asked Piroutek to do his next inspection of the clutch. He was certain they would have to replace the ThorPlas-Blue parts, but they were still working after 20 weeks of operation. With the old parts, Bus #342 had to be repaired every 3 to 4 weeks.

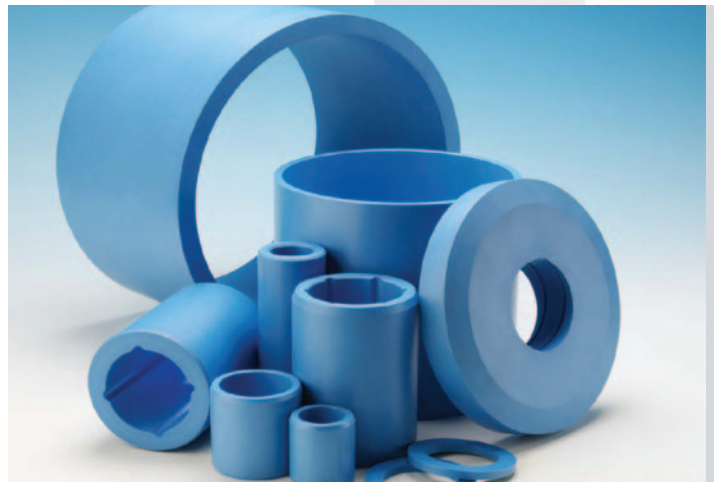
Lifetime lubricated grease and oil-free ThorPlas-Blue bearings
