AFTER-SALES SERVICE ENSURES SMOOTH SAILING...

Twenty million passengers a year take a ferryboat between Staten Island and Manhattan in New York. At no charge, they get a majestic view of New York Harbor on the 25-minute ride. Those five miles of water started to become a whole lot cleaner in 2004 when Thordon COMPAC propeller shaft bearings and SXL rudder bearings were installed on three Staten Island ferries.

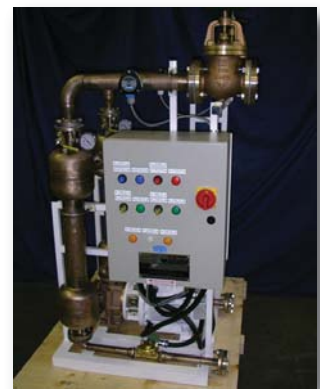
Improved Water Quality Package

Besides helping out with shipyard issues during the construction period, Thordon is equally attentive to items that could impact bearing performance after delivery. When shipyard engineers noticed premature wear on the separators of Thordon’s Water Quality Package, After-sales Service representative Jayson Stansfield replaced the separators with an upgraded unit and set up the water quality packages at an optimum flow level for the cooling water to reduce the amount of wear.
