Industry: Marine - Workboat

End User: Illinois Marine Towing Inc. U.S.A.

Application: Rudder Housing & Strut Bearings

Thordon Grade: SXL Rudder Bearings, RiverTough Tailshaft Bearings

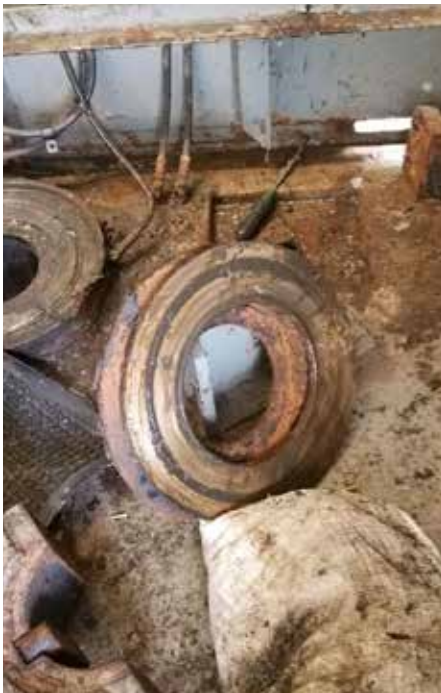
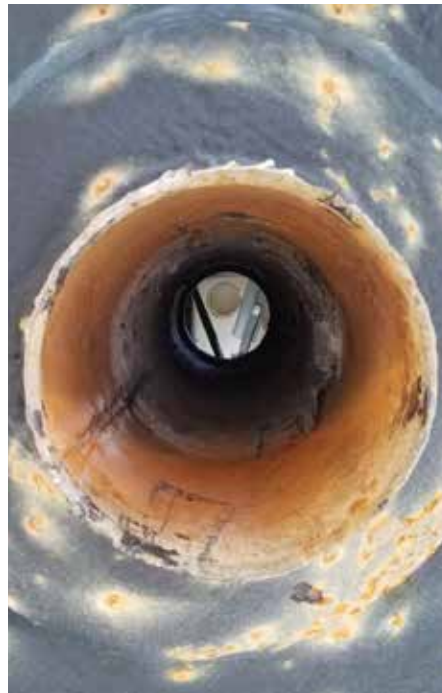
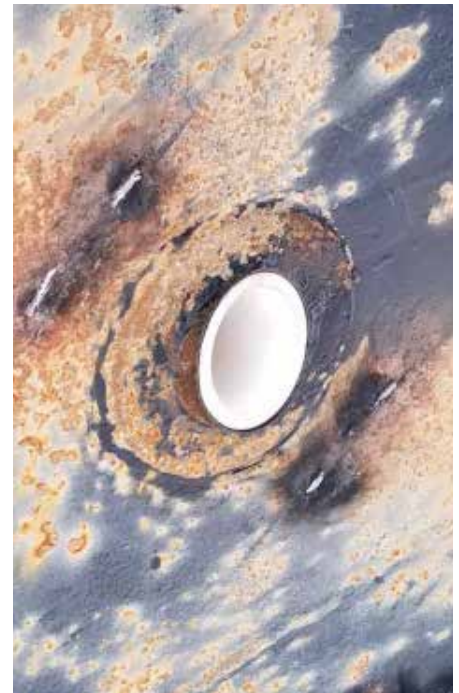
IMT was familiar with Thordon having used Thordon products on other vessels in their fleet. When IMT contacted Thordon, we connected them with our authorized distributor in the region, Mactech, to assist with the issues that the *Aggie C* was facing. Tim McCarthy and Monty Glisson from Mactech connected with IMT and a week later McCarthy was on site measuring all rudder bores (twelve total - six upper and six lower), two tailshaft strut housings, and the rudder steering system. Six of the bores (three upper and three lower) were out of round by 2.54 mm (0.1in) and the deviation in bore diameter was the cause of all of their past bearing failures.

Rudder housings bored and SXL bearings installed.

When McCarthy brought the issues to the attention of the Operations Manager and the Chief Engineer at IMT, he was able to convince them to repair the bores. Mactech are experts in this kind of work and not only would they repair the bores, but would also ensure that the bearings were machined to the proper dimensions and freeze fit into the housings.

McCarthy and two other Mactech team members travelled to the jobsite in March 2022. Together with two repairmen from the shipyard, they discussed the plan to get the bores back in the round and prepare the housings for the installation of new Thordon bearings. The work was done much quicker than the customer anticipated because all twelve rudder houses were completed in half the time frame thanks to the efficient work of the Mactech team.

When the boring repair was complete, measurements were taken and provided to a local machine shop in order to machine the bearings to the required dimensions. Thordon's SXL bearings were machined to be installed in the rudder housings and RiverTough bearings were machined to be installed in the tailshaft struts. One week later, the bearings were installed and the Chief Engineer and Operations Manager were amazed at the ease of installation.

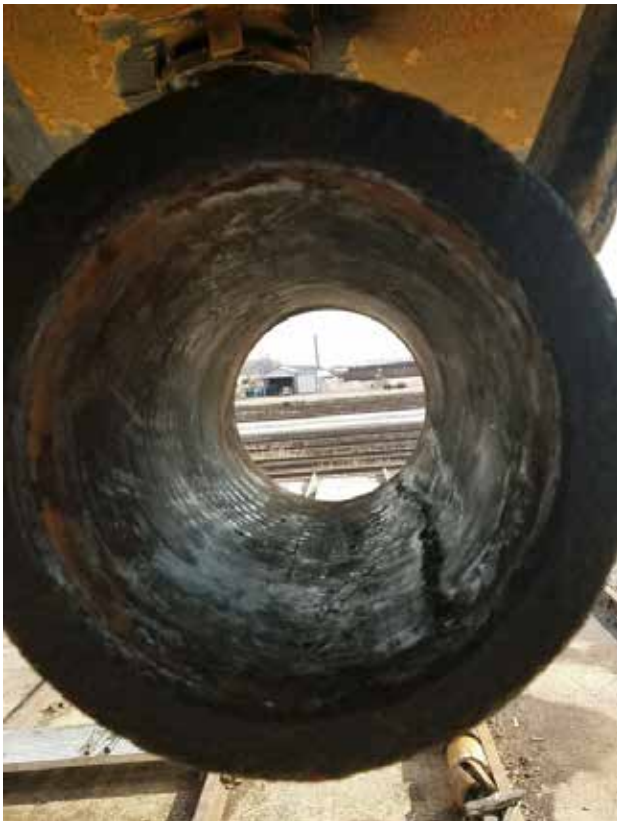
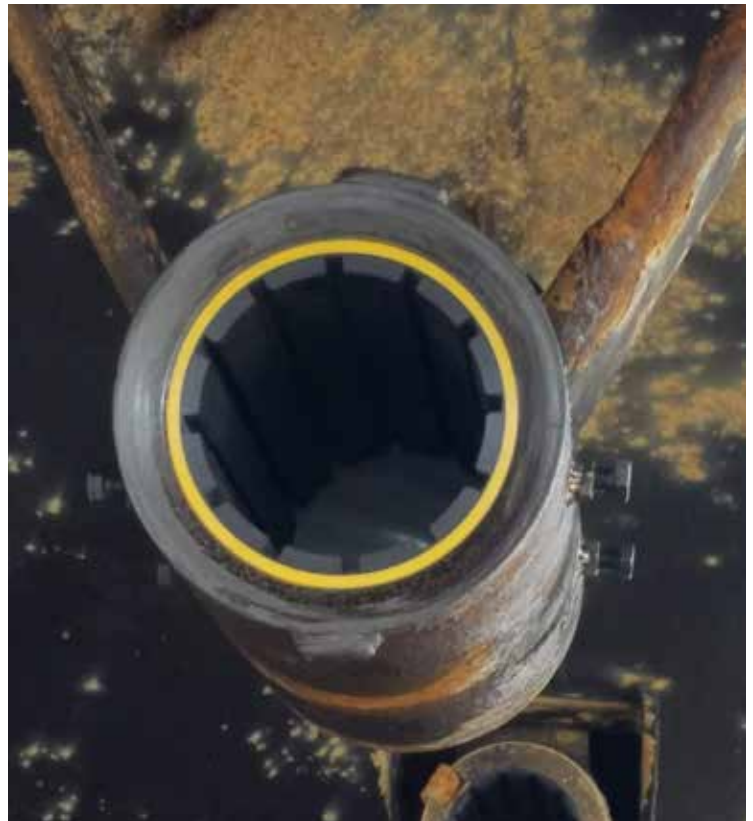
Strut tube before machining and after with RiverTough bearing installed.
