FINNISH NAVY FINISHED WITH RUBBER BEARINGS

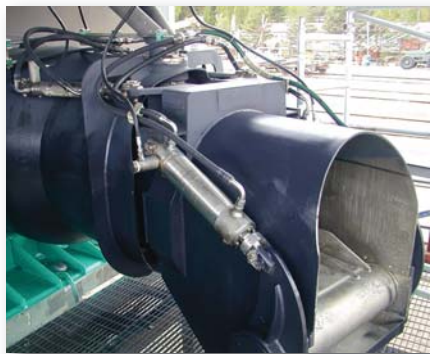
Water jet nozzle equipped with water lubricated Thordon GM2401 line bearings

Water jets are generally used in most Finnish Navy light and fast patrol vessels bigger than open outboard motor boats. The first of their fast attack missile boats to use them were the *Rauma* class vessels. In the propulsion shaft line is a water lubricated line bearing, located inside the stator of the water jet's jet pipe.

After 2000 hrs. running time, a visual inspection was made; both bearings appeared to be in good condition on the surface, with slightly more wear and minor dents on the rubber bearing. The shaft, however, had “clearly more wear on the rubber bearing side,” wrote Majanen. “Clearances (dry) were 0.6mm (0.0236”) with the Thordon GM2401 bearing, and 1.2mm (0.047”) with the rubber bearing.”
