MARCO POLO FITTED WITH THORDON AT MALTA SHIPYARDS

Marco Polo is a 180m (591ft.) cruise liner propelled by two 563.5mm (22.185") diameter tailshafts running on a water lubricated stern tube bearing system. She entered Malta Shipyards on the 19th March, 2007 for a 21-day refit which included the replacement of the two tailshafts with reconditioned ones, installation of two new propellers, conversion of stern tube bearings system to Thordon COMPAC from *lignum vitae*, installation of a Thordon Water Quality Package for each shaft and last but not least, renewal of the tailshaft coating system from conventional fibreglass to Thordon's Thor-Coat shaft coating. The Classification Society was DNV.

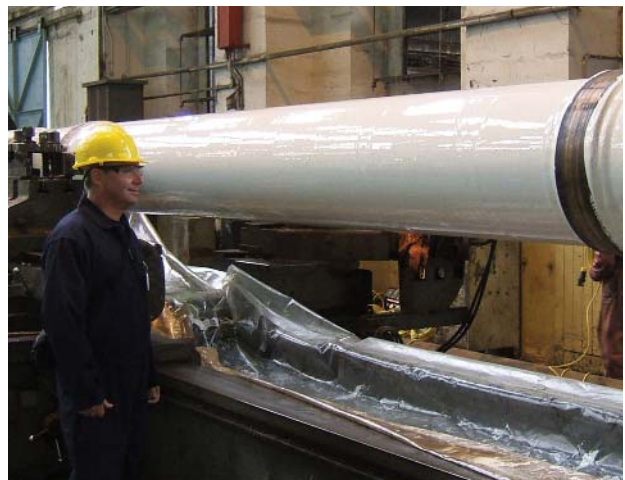
Thor-Coat propeller shaft coating for 563.5 mm (22.185") shafts of Marco Polo cruise ship

The bronze liners transition area had to be machined in order to create a profile for a resultant strong bond between the Thor-Coat material, shaft steel and bronze liner. This was carried out according to Thordon's recommendations from the Thor-Coat Application Manual. Once the machining was complete, the shaft was

sent to be grit blasted, returned immediately and put on the lathe where it was cleaned with isopropanol alcohol. Since the tailshaft had quite a large area to cover, only one Thor-Coat kit was mixed at a time, which allowed the shipyard enough time for proper application. The application was done in sections by means of brushes and consequently finished by a doctor blade mounted onto the lathe tool post, which ensured a uniform thickness and a smooth finish throughout. The liner transition areas were given particular attention since from our previous experience with applying Thor-Coat, we noted that this area is more liable for defects than the parallel areas. The application was carried out with the lathe turning at 3.4 rpm for brushing of adhesive and 5.8 rpm for towelling. **The application time of Thor-Coat was approximately 2.5 hours from start to finish.** After application, the first 24 hrs of the curing occurred while the shaft was turning on the lathe in order to avoid any possible sagging of the material. Several 500W lamps were rigged up on both sides of the shaft to accelerate curing time. After 24 hours, the Thor-Coat material, although not fully cured, was tough enough to touch and handle. A holiday detector was used to test the coating and occasional pinholes were detected and repaired locally.

Finally, any Thor-Coat on the liner surface in the transition areas was finished properly by means of a fine iron file and the tailshaft was ready for installation. The whole process was witnessed by the attending DNV surveyor.
